## FINAL REPORT

Fall Mission: November 1, 2006 – December 22, 2006

Luigi De Cesaris & Alberto Sucato, Restorers

“Conservation and Documentation of the Wall Paintings at the Red Monastery, Sohag”

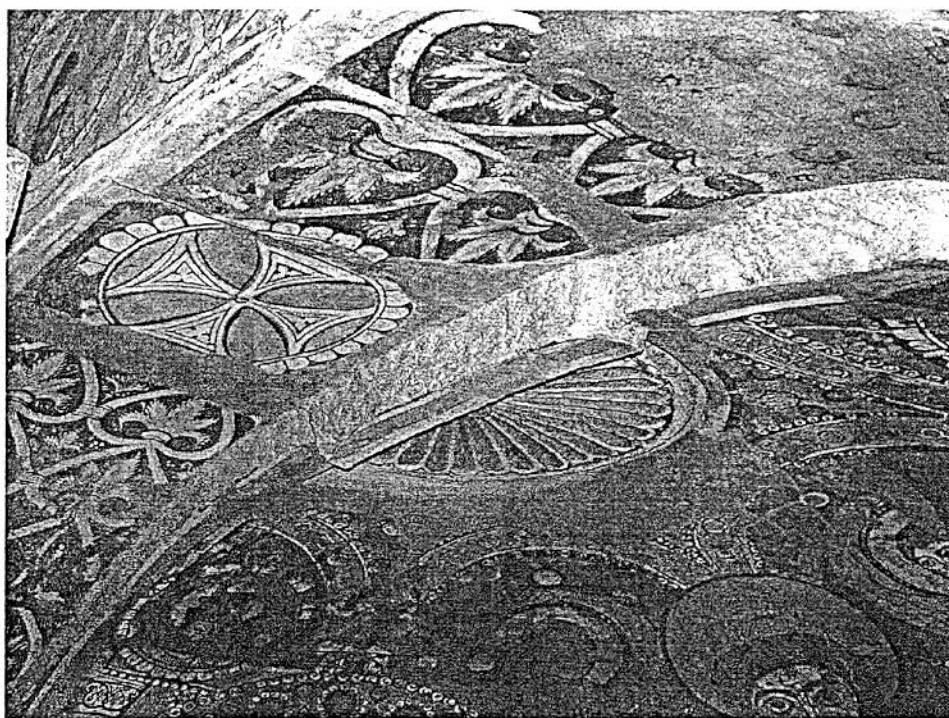
Fig. 1

During this phase, we tackled the delicate issue of removing old repairs carried out using mortar<sup>2</sup> not structurally compatible with the original mortar. These repairs were concentrated particularly in the central part of the apse and the area around the conch where structural instability over time has resulted in irreversible deformation, cracks and

fractures. (*Fig. 1*) (cf. graphic<sup>3</sup>).

Our approach to this phase took account of the following criteria: recovery of the painted areas covered by old pointing (the flat areas of painted plaster adjacent to the small columns in the clerestory, the entire area above the triumphal arch and, inside the apse, all the surfaces adjacent to fractures filled in during earlier work; in the north conch, some parts of the square pilasters and the lower part of the small decorated arch on the access door to the north transept); repairs using appropriate mortar in the areas where the removal of the old mortar used in restoration proved unavoidable and aesthetic treatment involving chemical and mechanical cleaning of that mortar which, for reasons of conservation, could

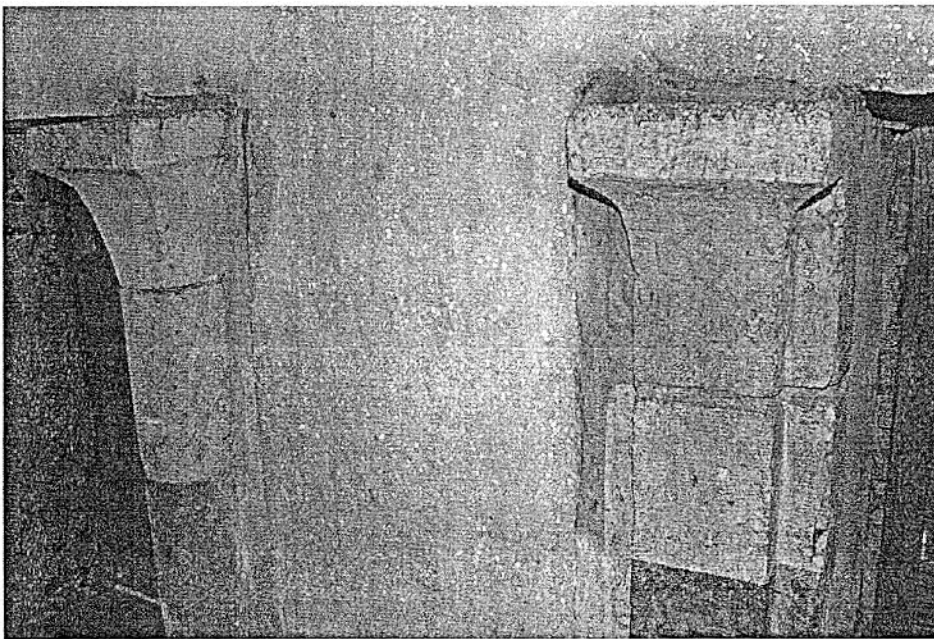
Fig.3

We are able to confirm the findings of our earlier work<sup>4</sup> with regard to the architectural structure. Ever since we began work in 2003, we have been aware that the original architraves of the windows were replaced in antiquity with new blocks of limestone (*Fig. 3*).

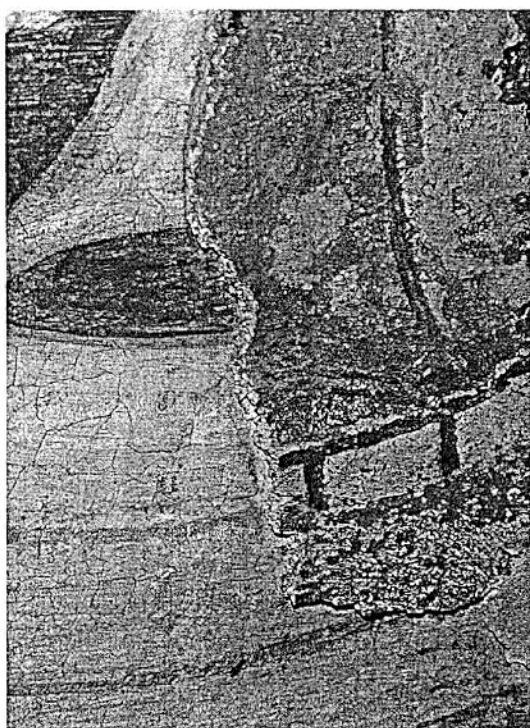
Fig 4

We can state with some confidence that the plaster used in the clerestory, for the smaller figures revealed in the area of the triumphal arch and for the niches in the second tier, shares the same characteristics. It is lime-based with inclusions of quartz sand that have very rounded, spherical<sup>5</sup> grains. This plaster, approximately 1 cm thick (*Fig. 4*), may be linked to that

defined in the previous report as being applied during the third phase<sup>6</sup>, that is, the phase of decoration preceding the *Virgo Lactans* or wax decoration phase.

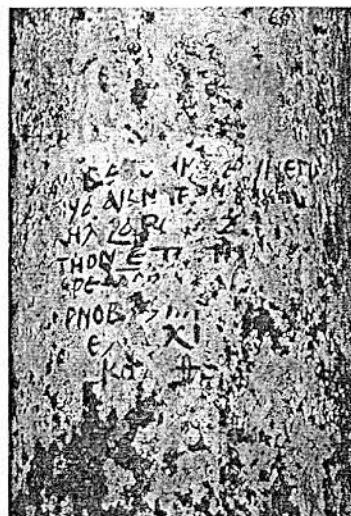
In the north conch, work was completed on all the surfaces including the granite columns partially painted with white wash and inscriptions (*Figs. 5 and 6*)

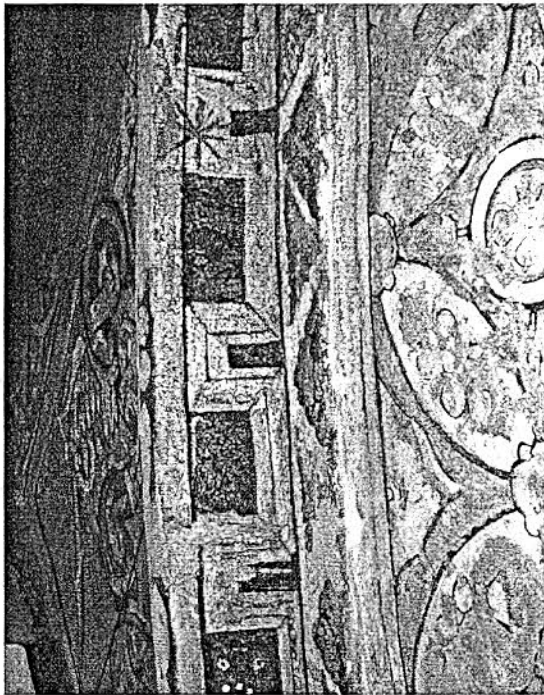
Fig.7

Starting at the top of the south conch, our work covered all the decorated surfaces between the small columns of the clerestory; the whole band decorated with circular geometric designs above the triumphal arch, the sides of the triumphal arch with the circular monochrome design relating to the white wash phase and the figures of an angel (left side) and a saint (right side) linked with the preceding phase of painting; the external arch in its entirety, including the moldings (*Fig. 7*),

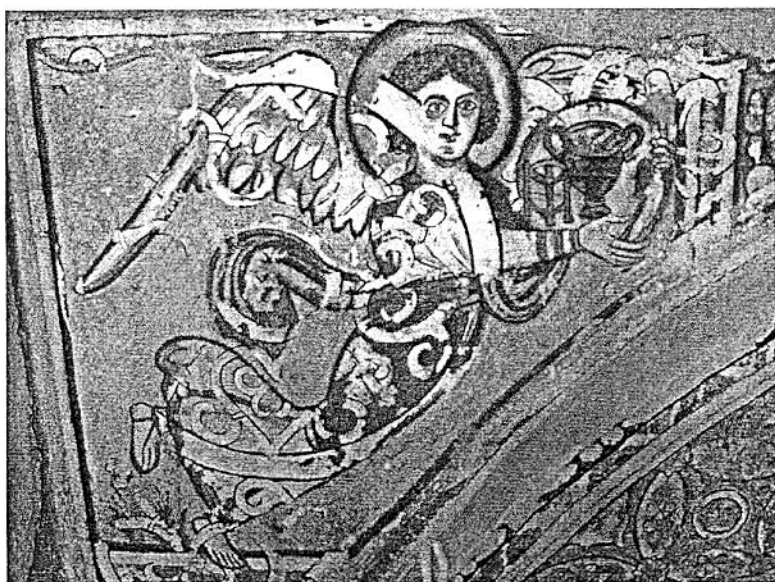
Fig.9

The angel bearing the symbols of the Eucharist (Fig 9) is particularly clear

and the recovery of the face in its entirety is of particular significance. Apart from the evangelist in the clerestory of

However, the artist covered the figures of the saint and the angel in the triumphal arch with circular decorative motifs. (*Figs. 9 and 23*).

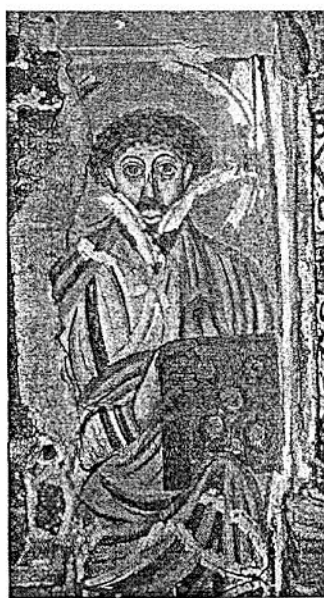
Fig.10

the north conch, this is the only example of a well-preserved face relating to the third phase of painting (Fig10).

The figure's fine state of preservation is owing to the almost total loss of the white wash decoration that covered it in the past. Subsequently, the portraits of two saints were discovered at the base of the external arch. These small figures, connected with the phase of the white wash artist, were painted at the base of the triumphal arch, on the left and right respectively (*Figs. 11 and 12*).

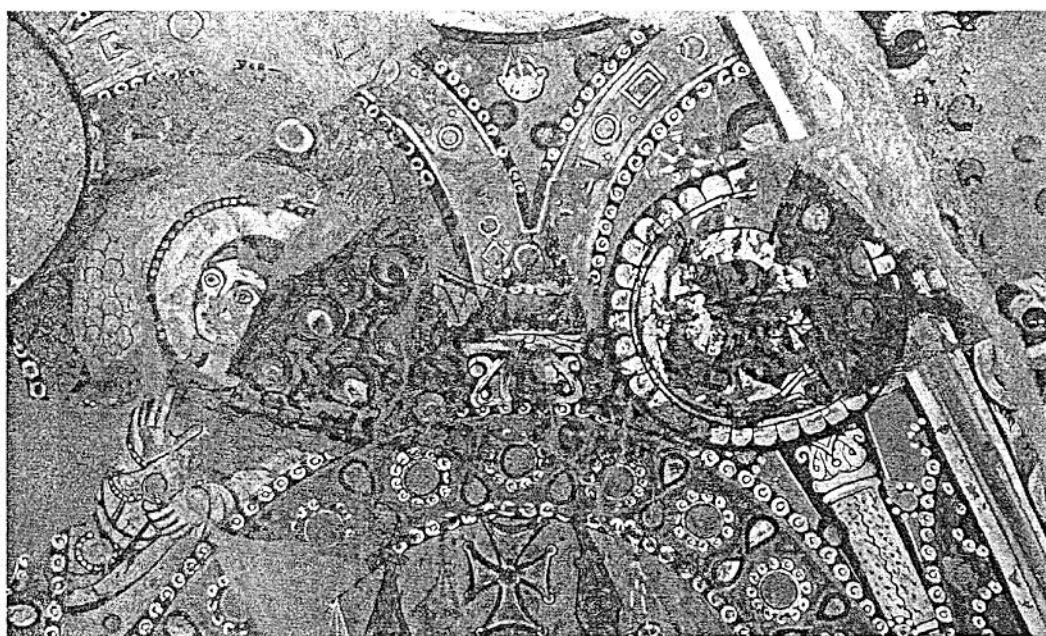
Approximately thirty centimeters to the right and left of the Pantocrator's halo, there are two horizontal bands of yellow on which are depicted pointed trees bearing apples painted using the encaustic technique (*Figs. 13 and 14*).

it corresponding to the pigments and binders used in the paint layer beneath. These pigments and binders, owing to their own compositional characteristics, have had an adverse effect over time upon the adhesion of the overlying paint layer (the upper part of the south apse which revealed the line of trees associated with the third phase of painting, the right and left of the triumphal arch, the ground level niches in the north conch) (*Figs. 13, 14; 24, 25*).

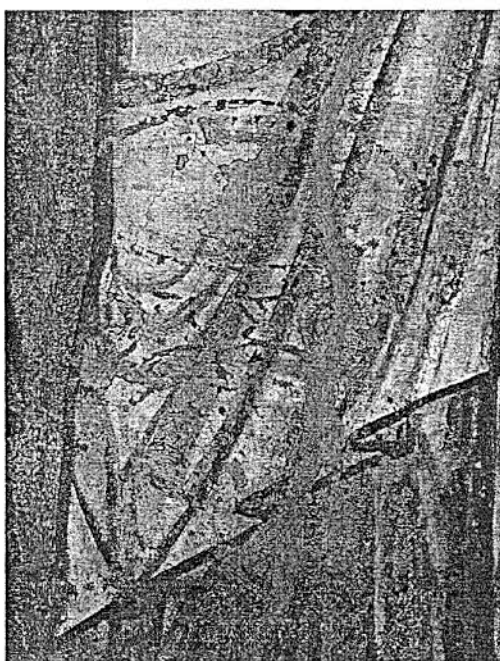
Fig. 15

off there are glimpses on the left and right of a different underlying architectural motif with ornate curvilinear elements. There are designs composed of red and white lines at the level of the lower part of the evangelists' robes, one of which is reminiscent of a goblet (Fig.15).

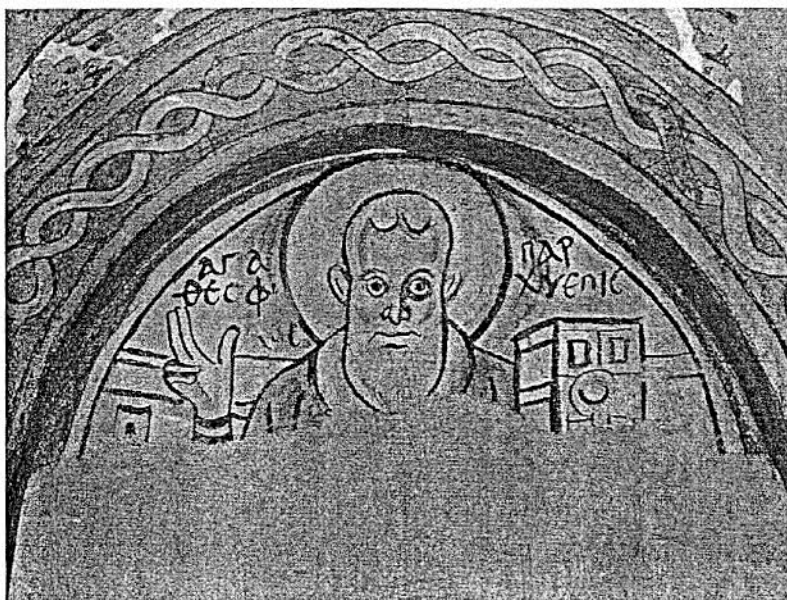
Fig. 20

In the north conch, the entire decorative scheme of the first register could be ascribed to the third phase with some portions reworked by the whitewash painter. Some of the latter portions are well preserved, such as the saint on the *prothesis* access door (*Apa Teophilos*; Fig. 20), and some highly fragmented, for example in the niches.

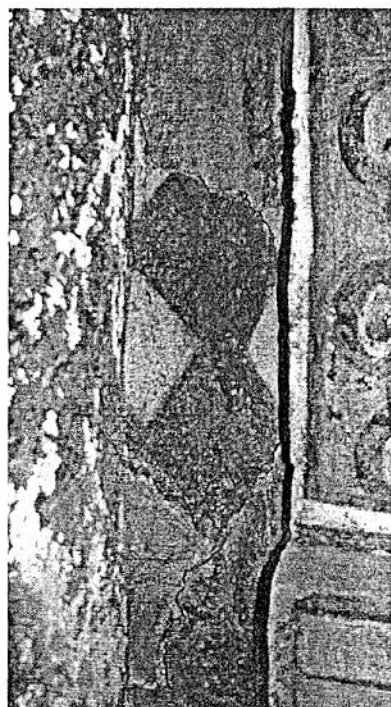
Fig. 21

Down behind the last column on the right, beside the jamb of the *prothesis* access door, in an area where the plaster has fallen off, an area of geometric decoration made up of red monochrome diamonds was revealed. Given that this lies below the same plaster used in the third decorative phase, it can be attributed to the first or second phase of painting in the church (Fig. 21).

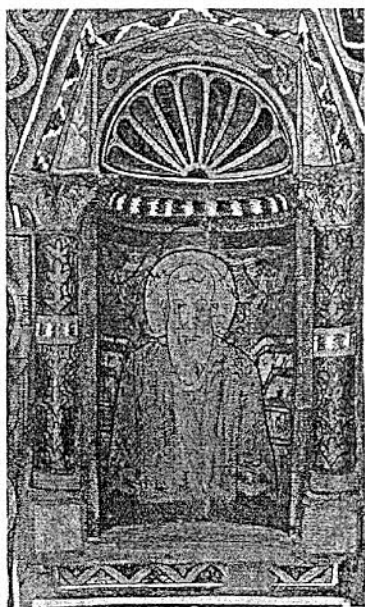
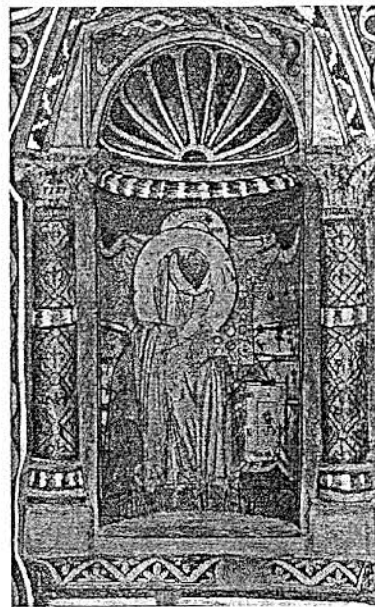
In the second register, the saints represented in the niches were “repainted”. Moving to the two niches of the first register in the north conch, as described in the 2005 report, the painter completely altered the iconographic scheme and the dimensions of the figures of the saints, changing them from full-length figures to half-length<sup>11</sup> (*Figs. 24 and 25*).

Over all the other painted surfaces the layer of dirt appeared to be made up of natural deposits, such as residual particulate matter and carbon, as well as a great deal of wax residue from candles arising from the building's religious function. This continuous layer of dirt is most evident in the first tier to a height of approximately 1.80 m above ground level, as a result of direct exposure to oil lamps and candles as well as the hands of the congregation. It should be added that the entire area to head height was that most heavily targeted in the cleaning operations carried out by different bodies. These past attempts at conservation have irremediably damaged the appearance of many parts of the first tier, the most obvious examples being the two niches on the north side. In the left-hand niche only traces of the last painted layer remain, hinting at the outlines of the images beneath. The right-hand niche, however, has lost nearly all its white wash apart from on part of the beard and the halo, revealing the earliest painting almost in its entirety (*Figs. 24 and 25*).

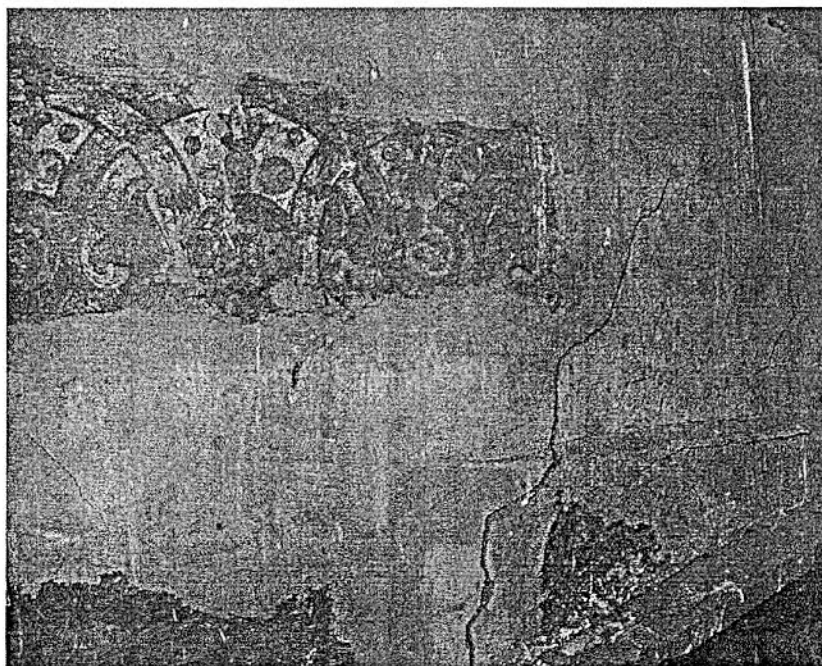
Fig.26

Analyzing the state of preservation of the plaster of the south conch and the areas above it, we observed that the plaster under the dome and around the triumphal arch was considerably fragmented and failing to adhere in a manner similar to that encountered in the north conch. Old falls of plaster had been repaired with unsuitable mortar which encroaches heavily on the original plaster (*Fig. 26*) and paint layer, as described in detail at the beginning of the report.

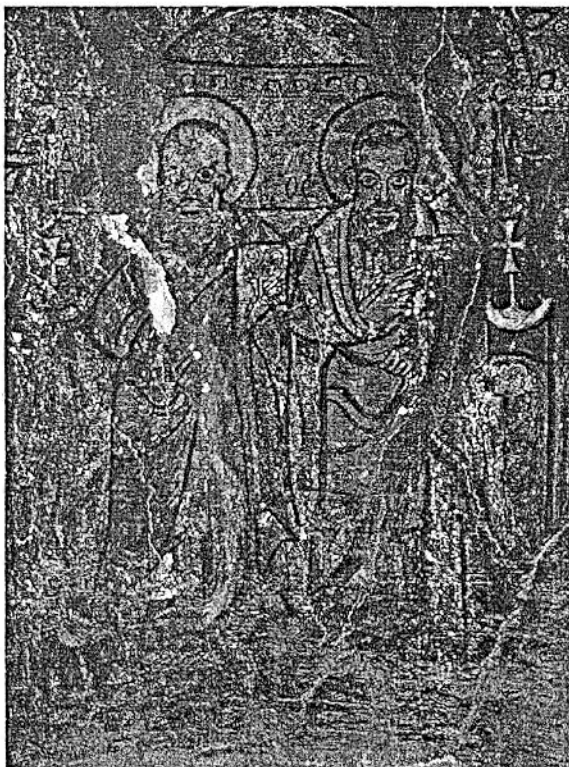
Fig.28

Following a vertical line downwards from the triumphal arch, there are various cracks (Fig.28) testifying to the old problem of structural instability in this area which led the *Comité* to try and reestablish the architectural equilibrium of the building.

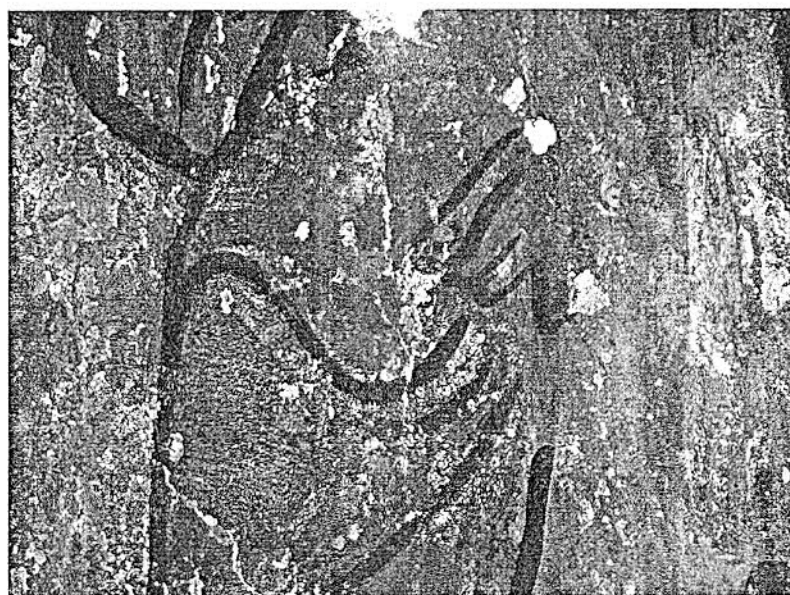
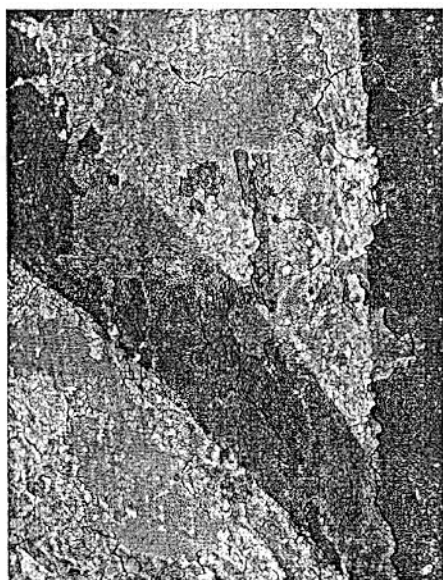
The paintings in the apse and the paintings inside the niches of the first and second tiers were the object of conservation work that can only be dated roughly to some time during the twentieth century. These surfaces are coated with a thick layer of heavily oxidized<sup>12</sup> oil- and resin-based varnish beneath which can be seen some touches of red-brown and more rarely, gray-green. The black outlining of the figures has been roughly yet systematically painted in over the varnish<sup>13</sup> (*Figs. 29 and 30*).

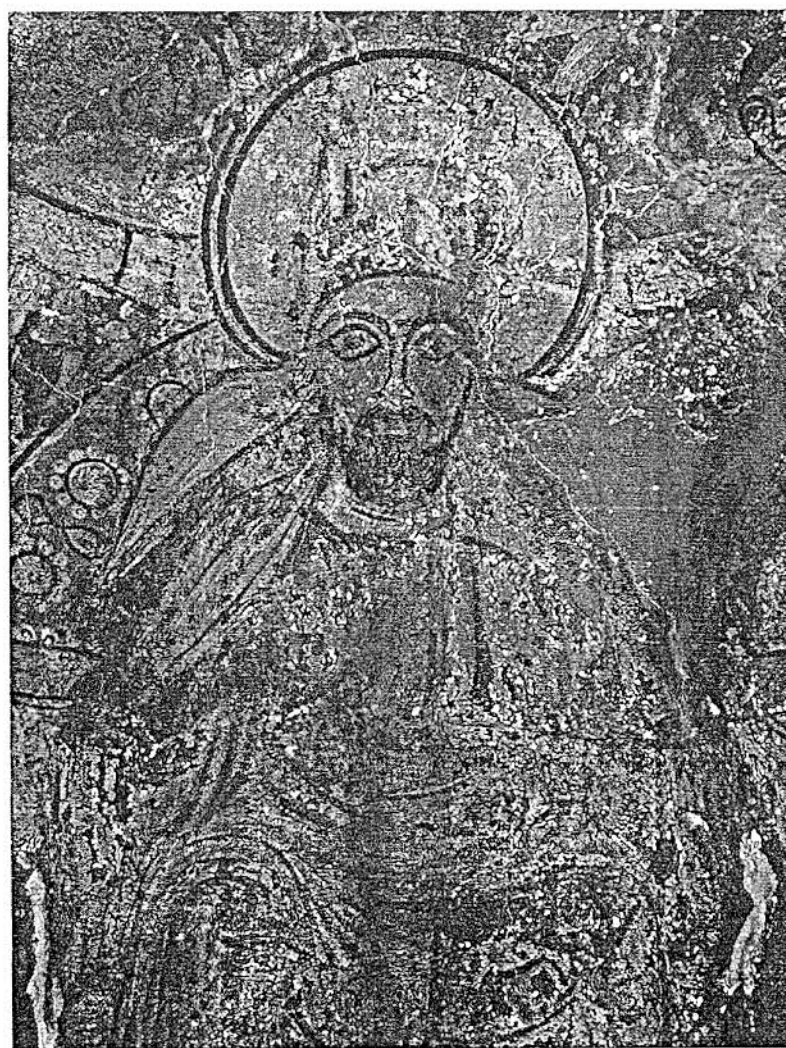
Fig.31

Cleaning work carried out on the figure of Christ enthroned has proved ruinous in its effects. Clearly, vigorous mechanical cleaning<sup>14</sup> was attempted with disastrous results, particularly with regard to the body of Christ, causing deep abrasions and detaching the painted layer and white wash. These efforts were concentrated in particular on the central area around the benedictory hand<sup>15</sup> of Christ and the halo. Here, the individual carrying out the work, thinking that he was

uncovering the remains of a crown on the head of Christ, was in fact revealing part of the capital painted under the halo<sup>16</sup> (*Fig.31*).

The capital was actually part of the first phase of composition that the painter most probably intended to cover with a light coat of whitewash in order to paint the central figure

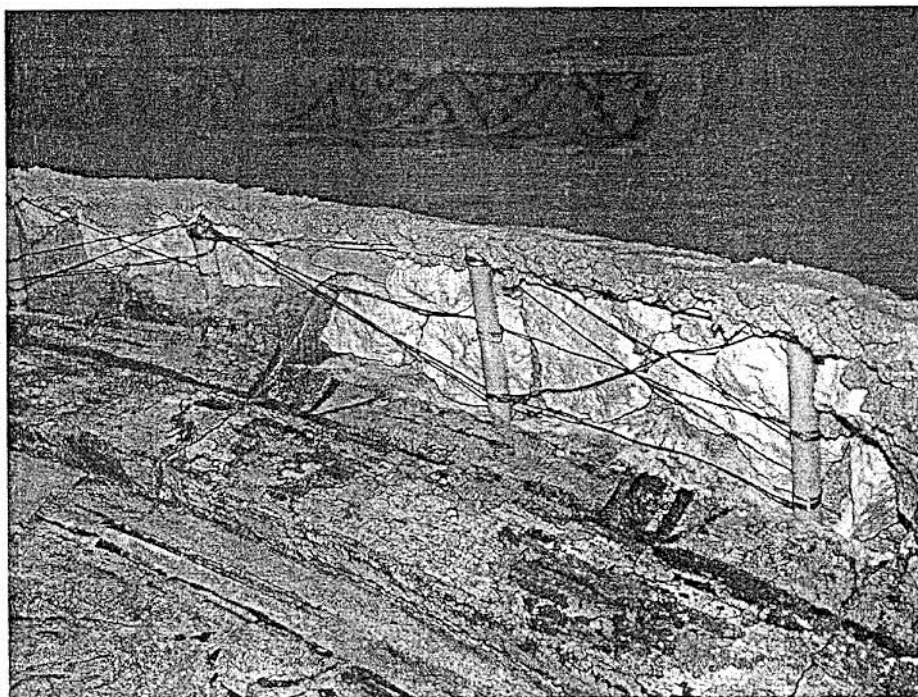
Fig.32

In order to restore the large gaps in the architecture and moldings we inserted fiberglass-reinforced plastic rods in the masonry and strung copper wire appropriately treated with acrylic resin between them (*Fig.32*).

This was necessary to ensure that the mortar used in the repairs would adhere over the long term. This mortar was applied in layers, using coarser grained mortar first and thinner mortar on the surface.

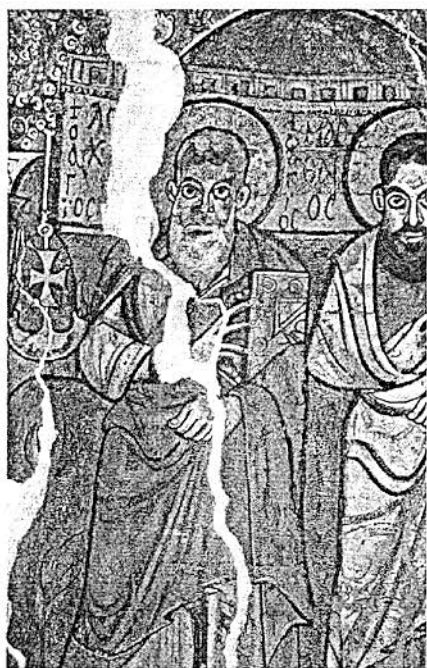
Fig.33

We pointed the cracks and edges of the plaster where this was necessary to prevent the liquid mortar from leaking out or provide a further immediate support in the areas where the plaster was not adhering. Where the painted palimpsest was not visible beneath them, the cracks and gaps in the plaster were brought up to the level using mortar similar in composition and appearance to the original but with less mechanical resistance (*Fig.*) [number missing – Trs.]. The structural instability affecting the vault of the apse required the use of epoxy resin, given the urgent need to consolidate this effectively (*Fig.*) [number missing – Trs.].

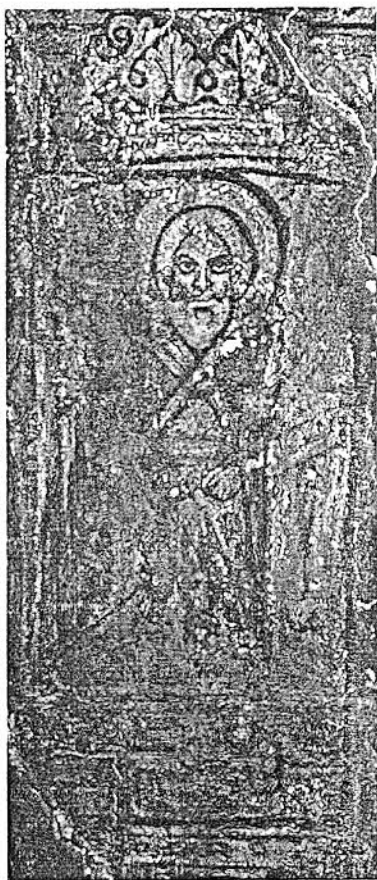
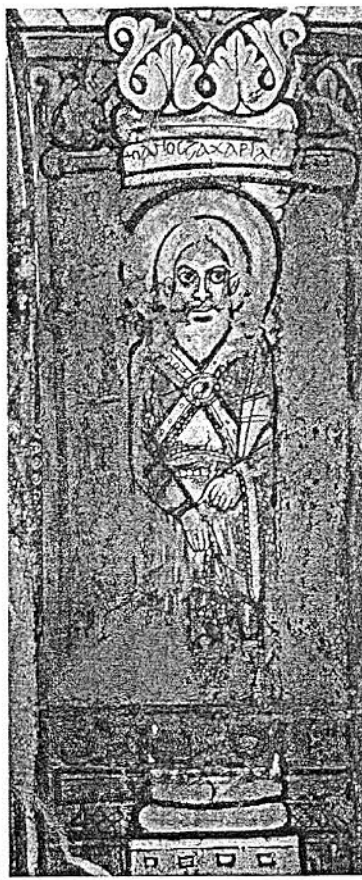
We employed the methods and materials used during the 2003 mission to clean the paint layer. The cleaning system developed during these missions has proved particularly effective and safe for the constituent materials, reducing mechanical stress on the painted surface (aspiration with organic solvents and the use of compresses to dissolve substances applied over the paint layer) (*Figs. 35 and 36*).

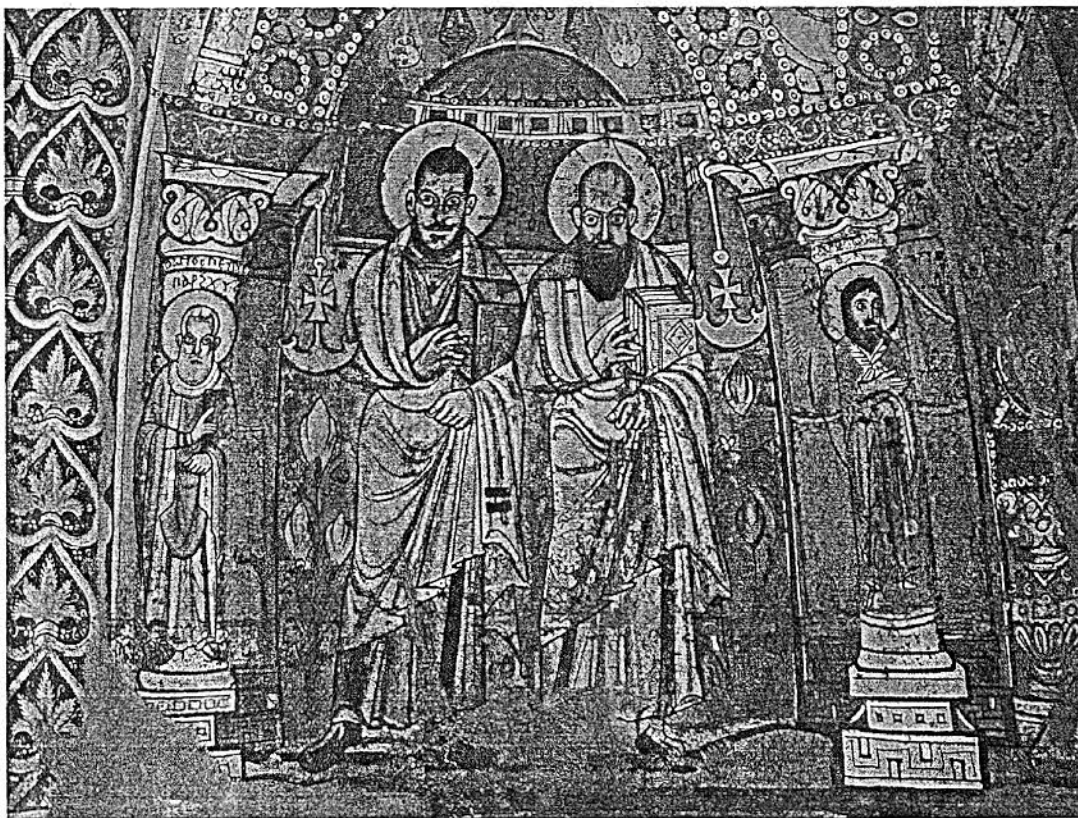
Fig.38

This restoration technique enabled us to restore the legibility of the painting without rendering it liable to misinterpretation. The toning down of the gaps was inspired by the original patina visible through the oldest gaps (Fig. 38).
